# Space Safety

Prof. Maciej Konacki

# Space debris

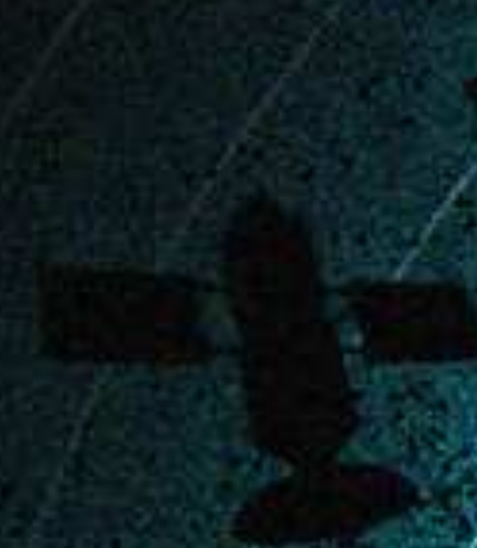
estimated number of debris objects in orbit

34 000

> 10 cm

900 000

1 cm - 10 cm

128 000 000

1 mm - 1 cm

Source: ESA, 18 November 2020

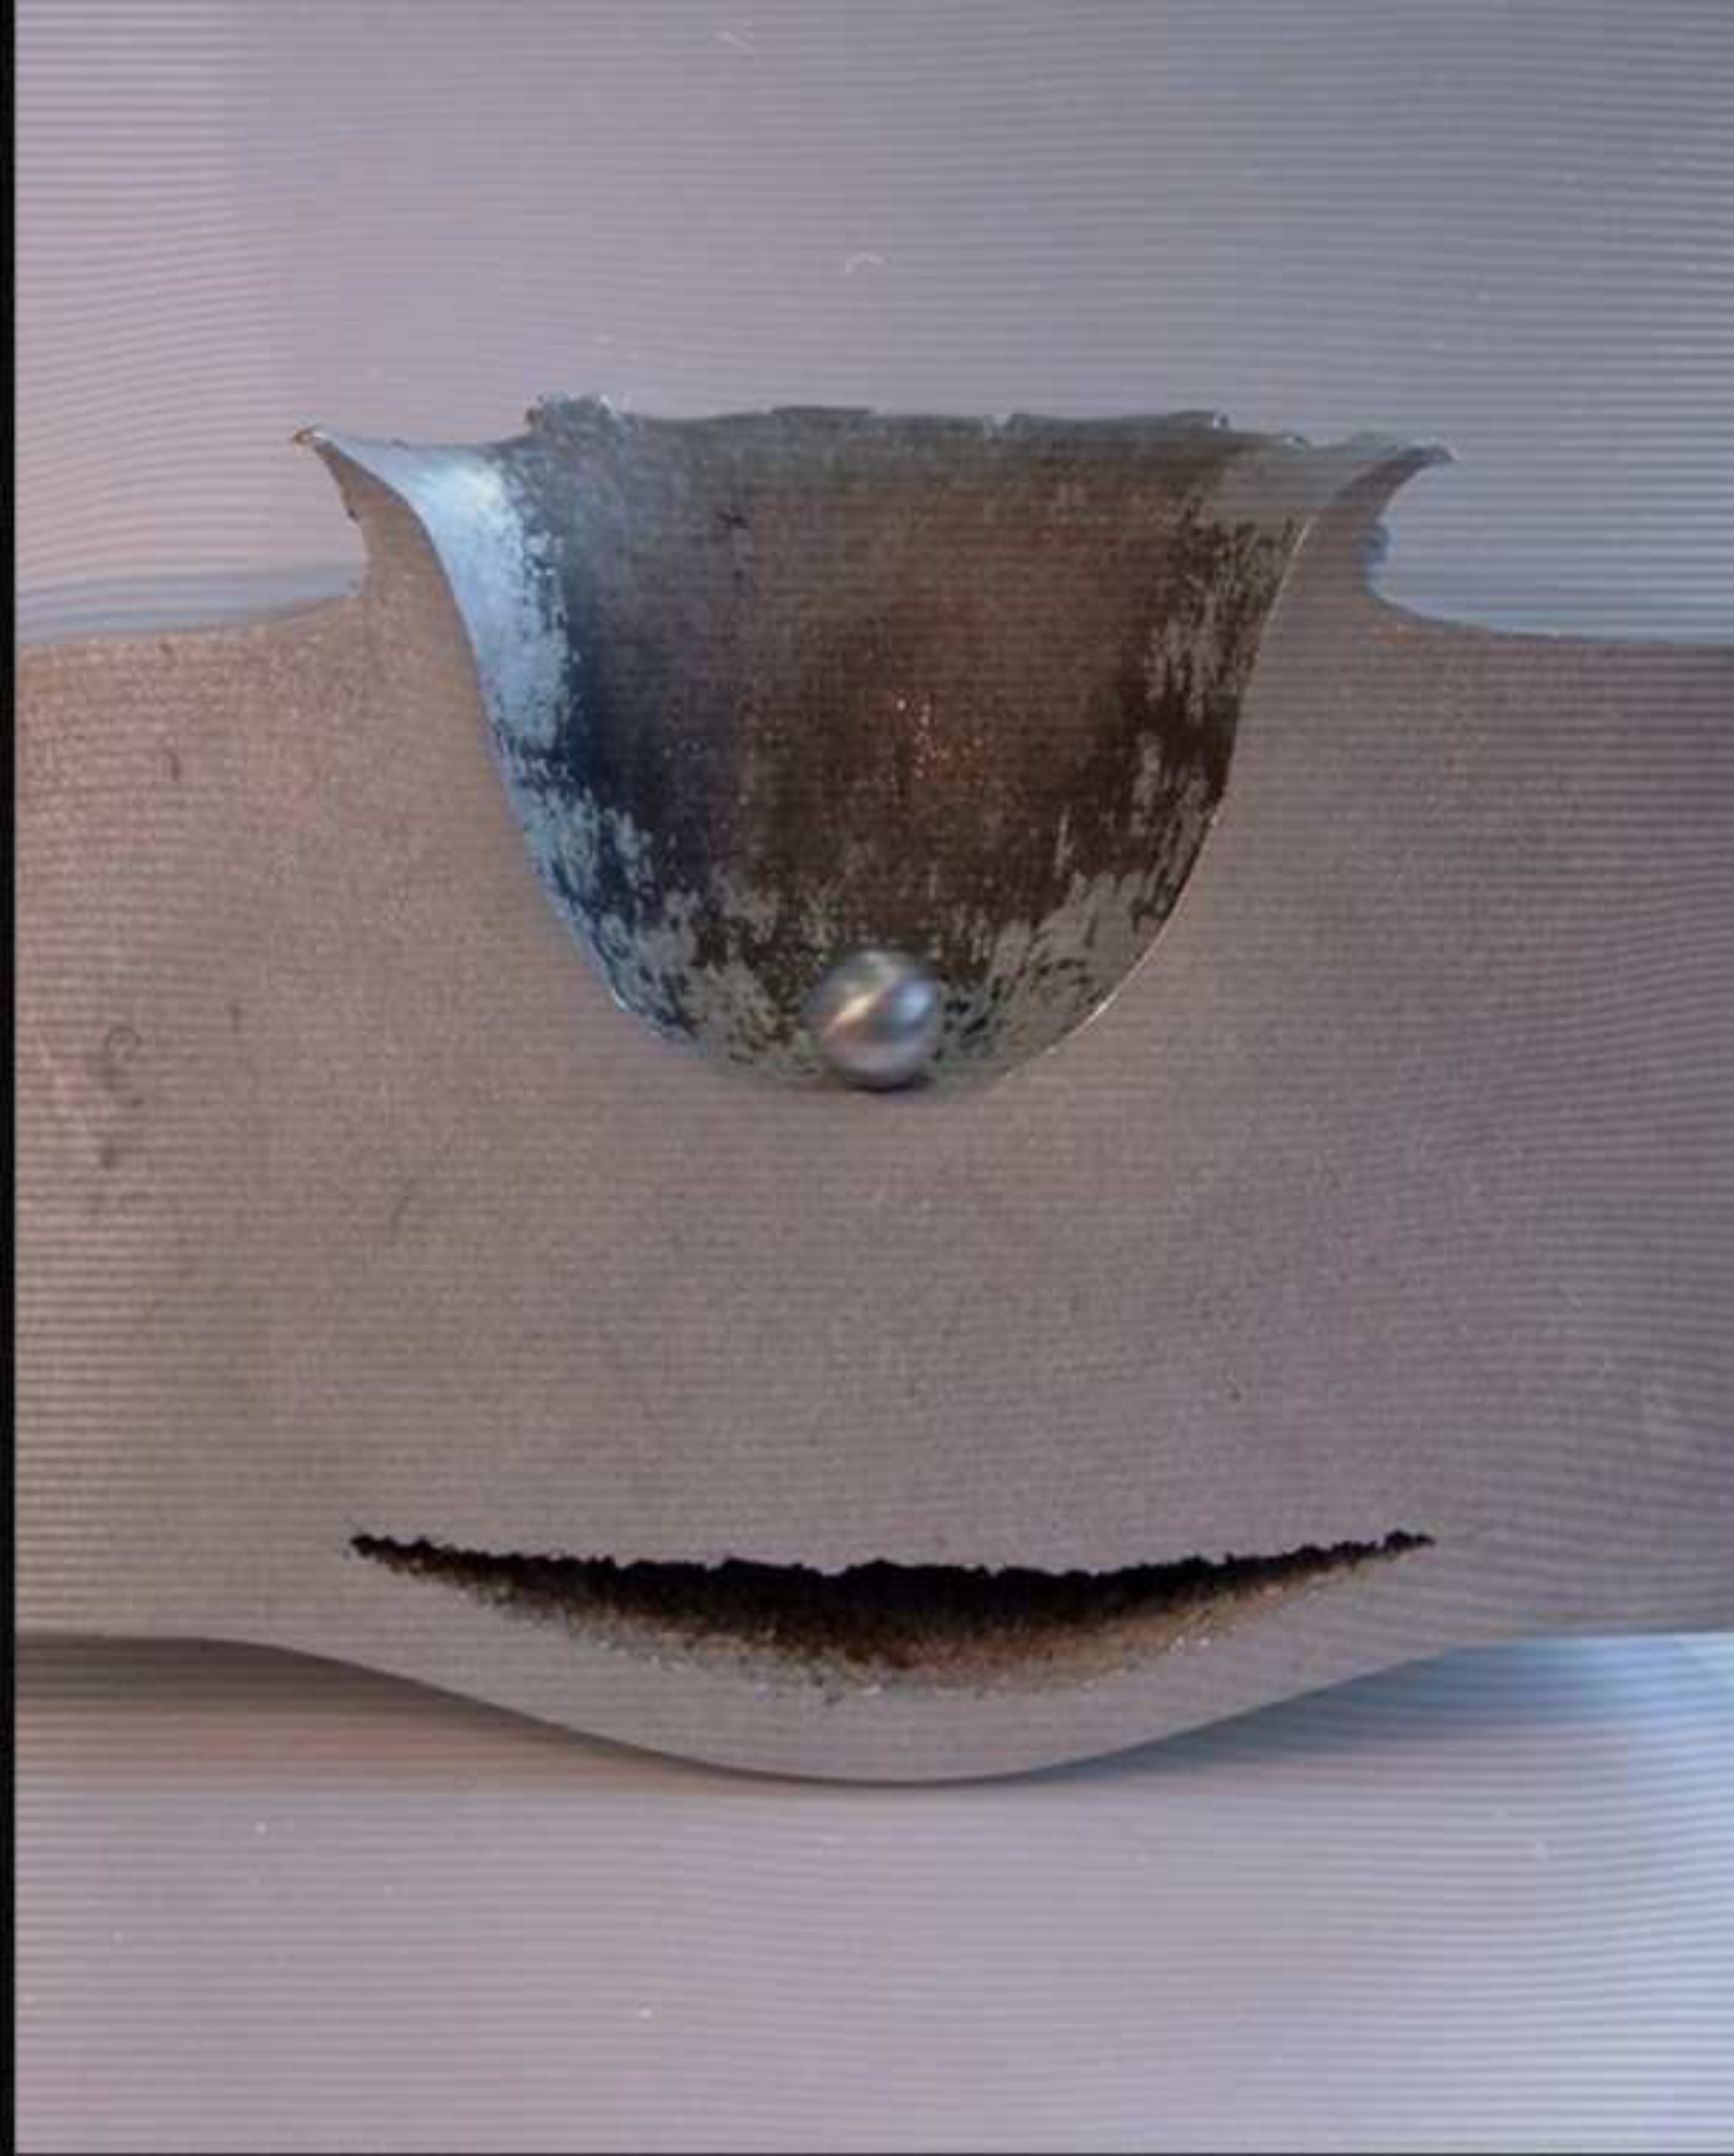
Probability of the collision of a LEO satellite (cross section of 10 m<sup>2</sup>) with space debris 0.1–1 cm in 10 years of the satellite's operation is close to one.

Al sphere diameter: 1.2 cm

Al sphere mass: about 1.7 g

Impact crater diameter: 9.0 cm

Impact crater depth: 5.3 cm

Speed: 6.8 km/s

Al block width: 18 cm

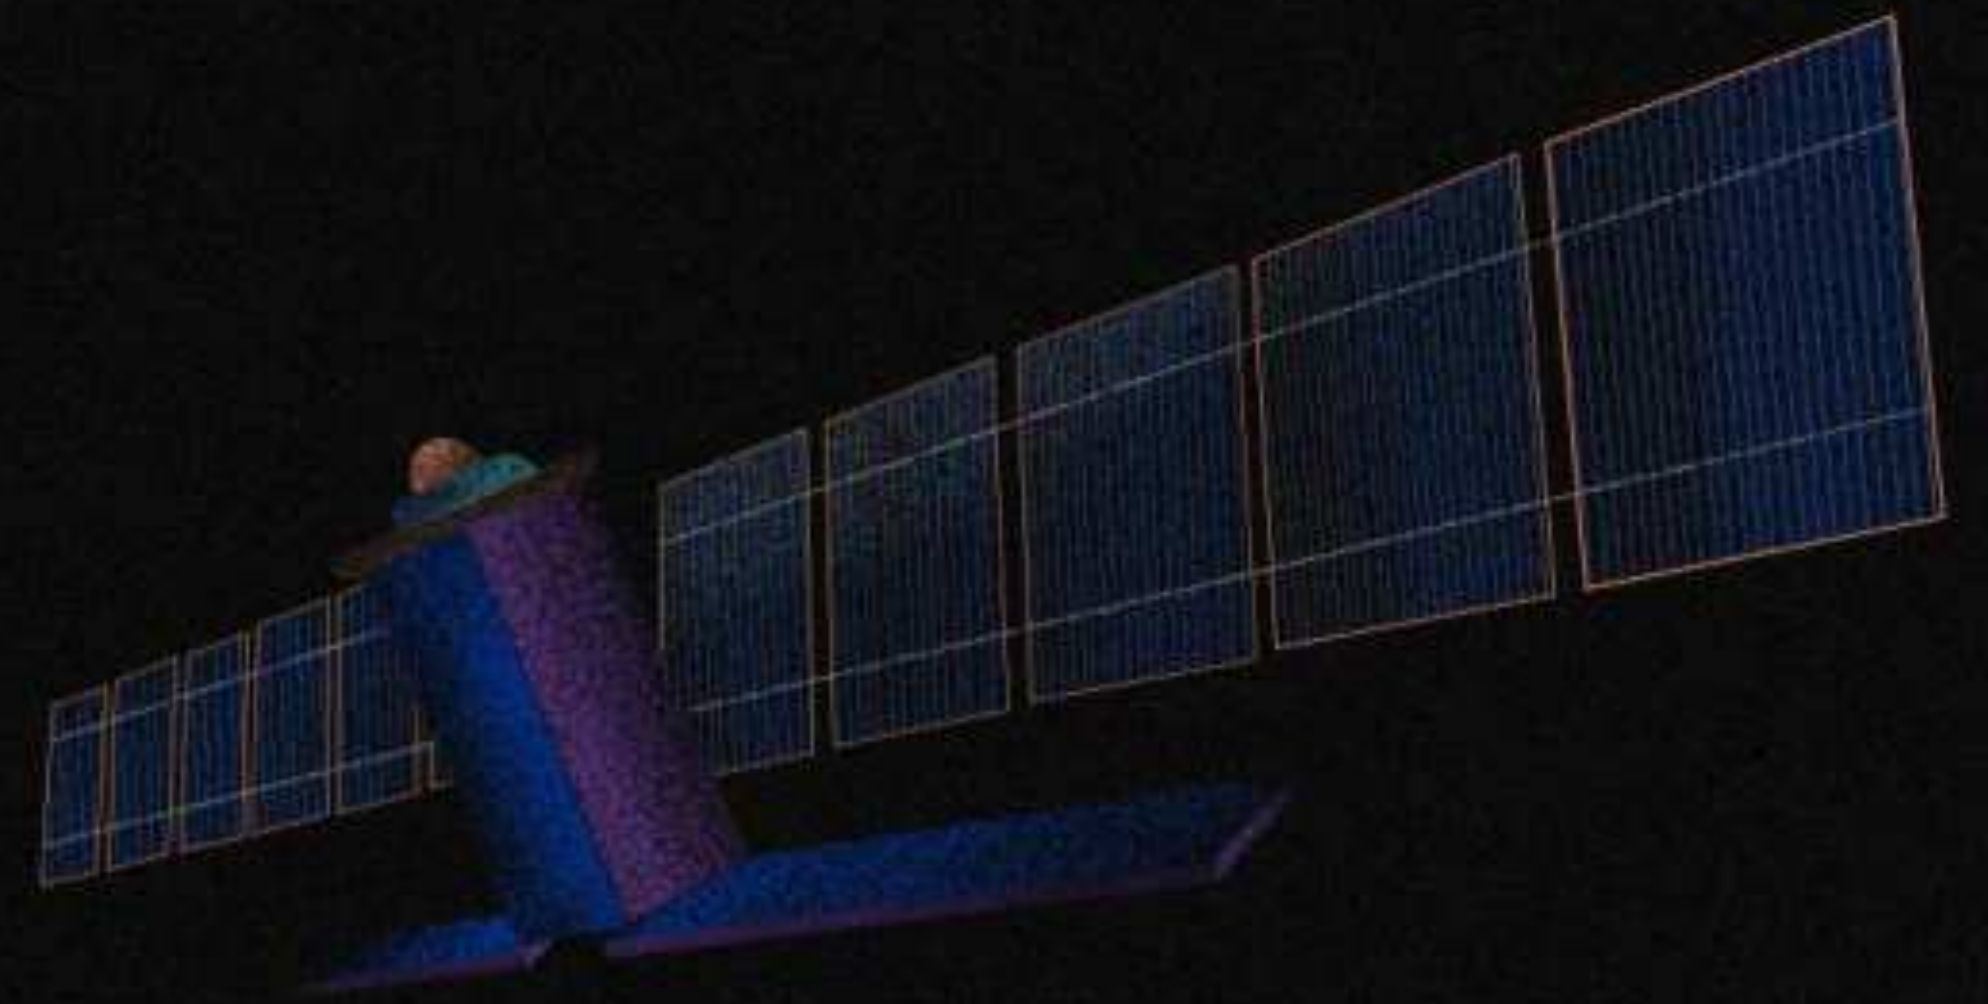
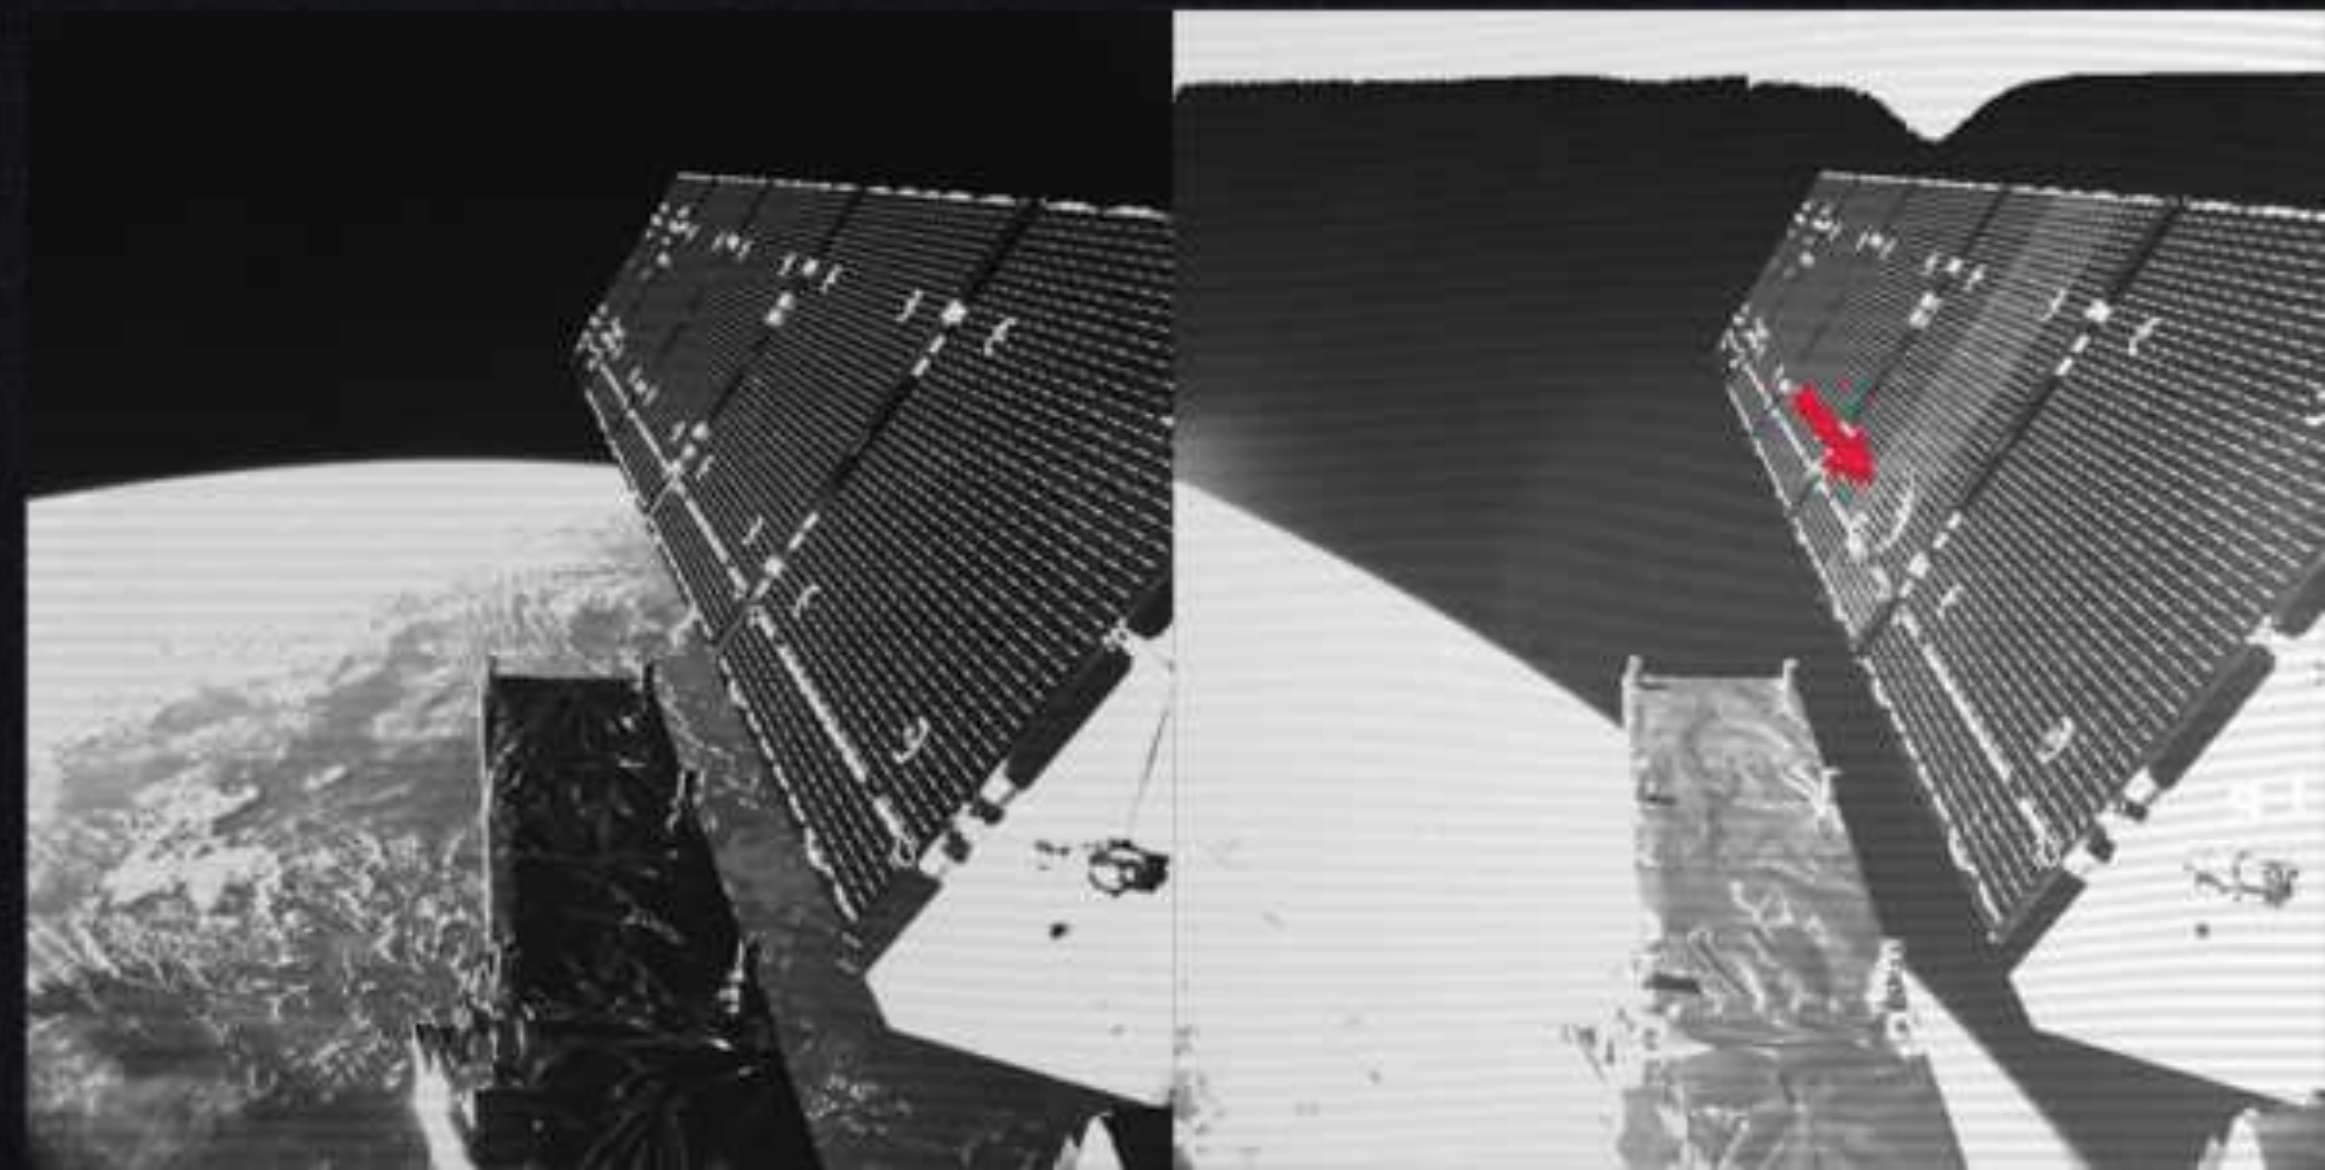
The picture shows Sentinel-1A's solar array before and after the impact of a 5 millimetre size particle on the second panel. The damaged area has a diameter of about 40 cm.

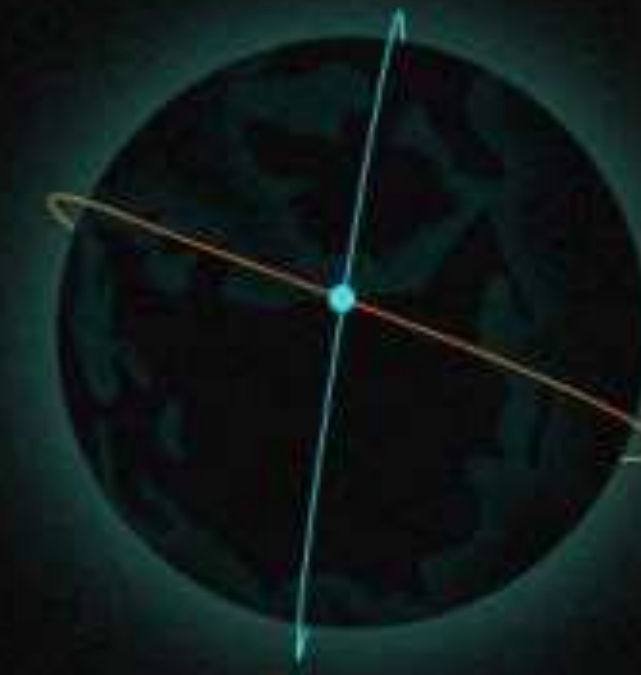
Collision of two communication satellites:  
**Iridium 33** (active, 560 kg) and  
**Kosmos-2251** (debris, 950 kg)

Speed of collision 42 000 km/h, altitude 790 km

point of  
collision

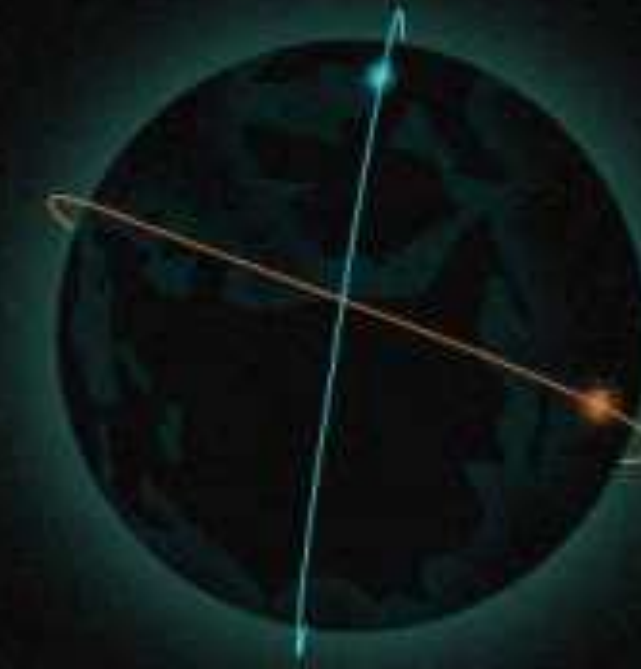
debris fields  
after 10 minutes

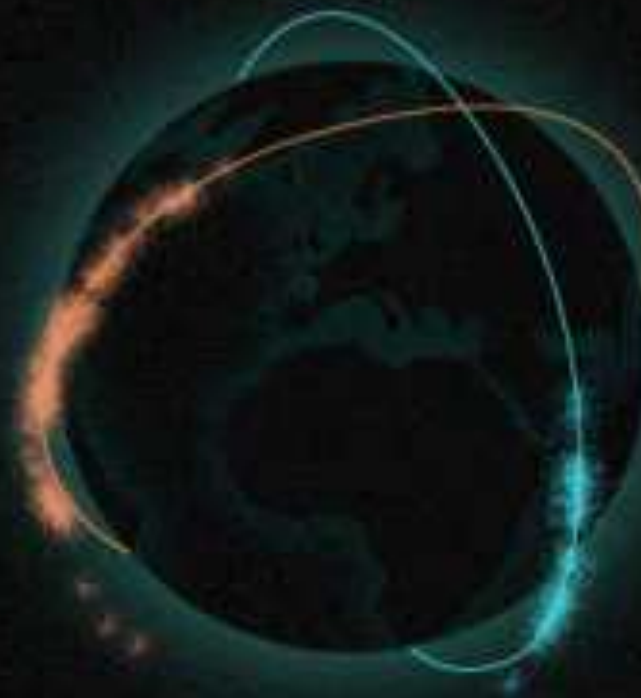
debris fields  
after 3 hours

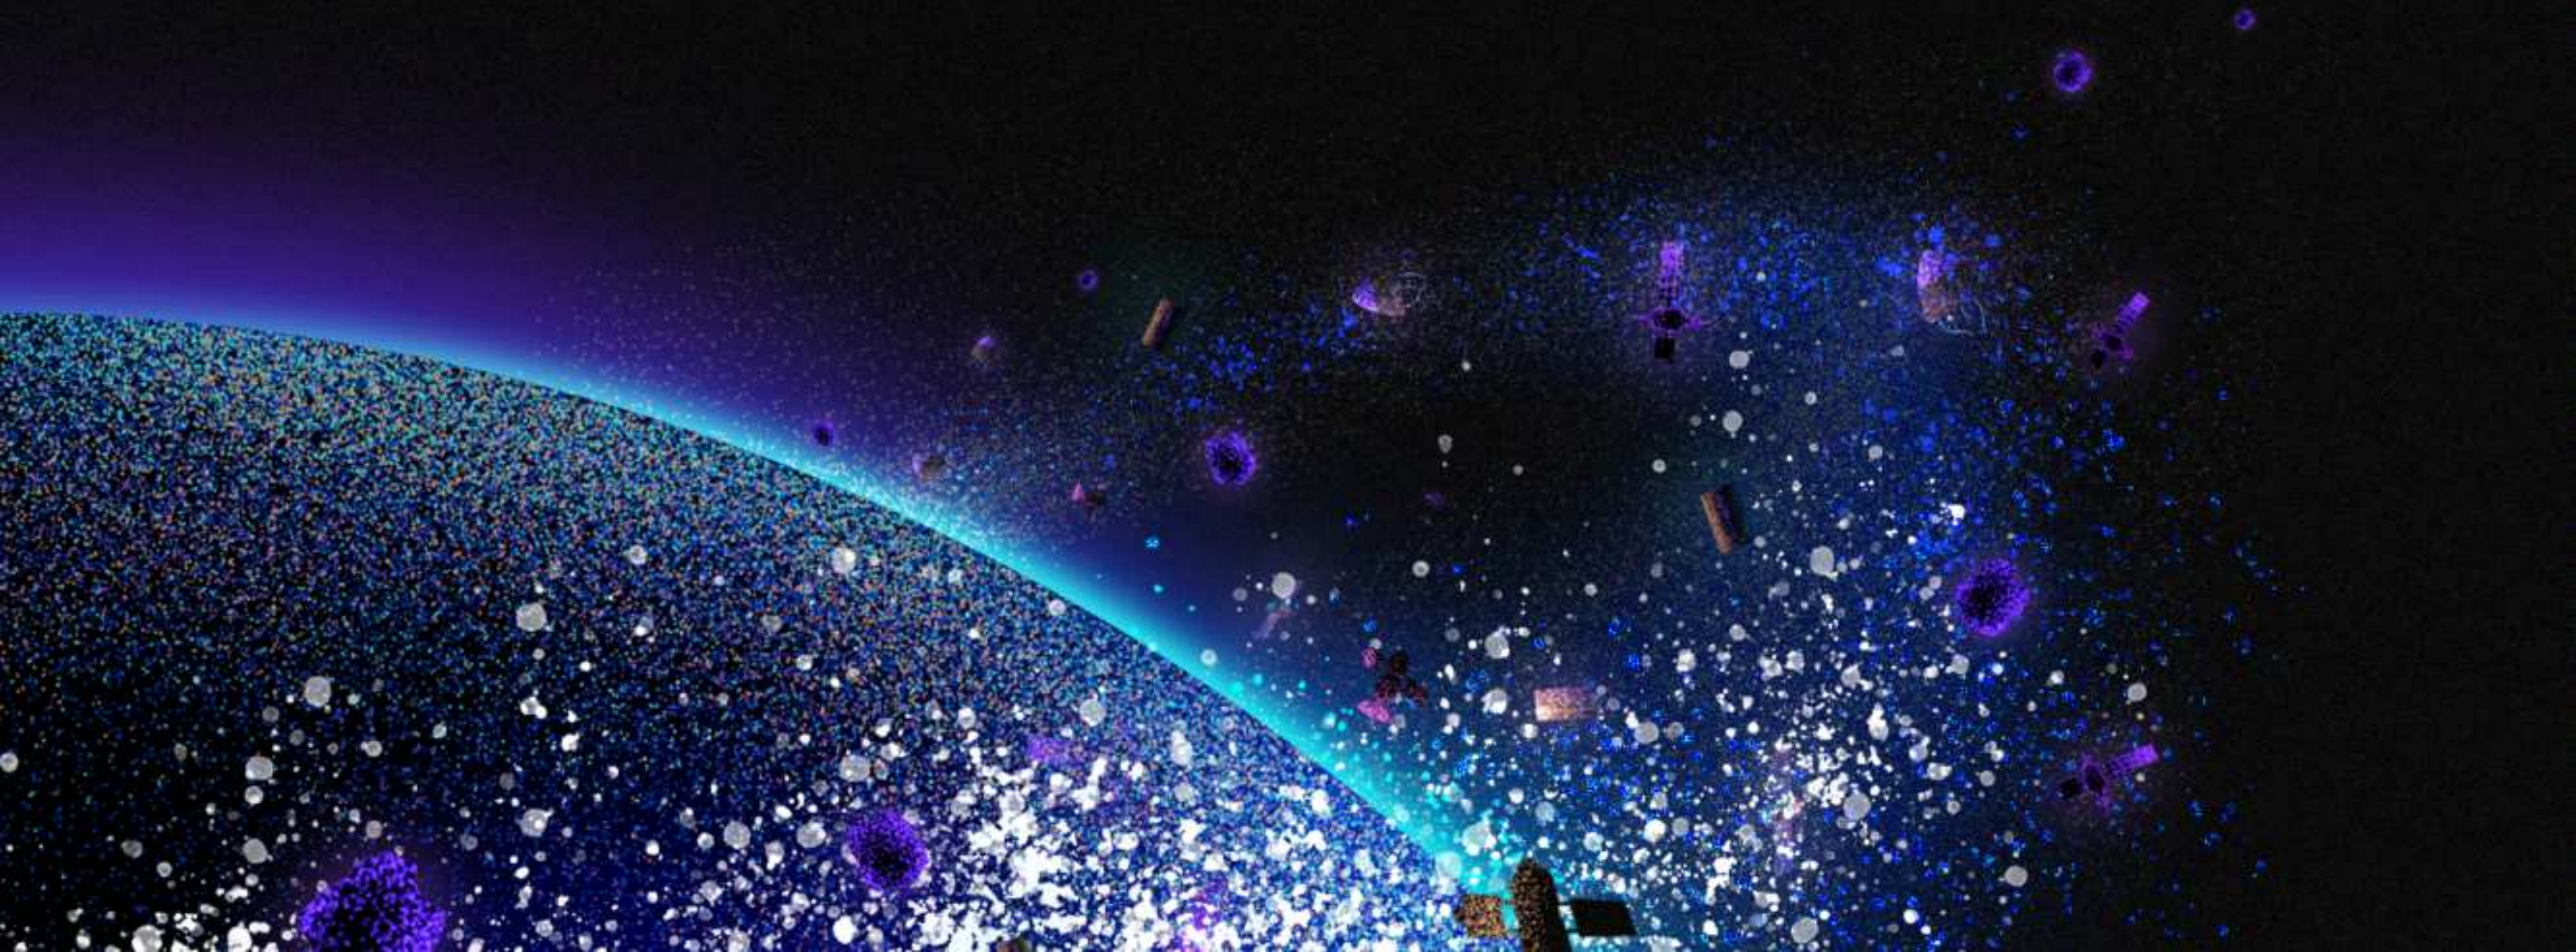
Collisions create more debris creating a runaway  
chain reaction of collisions and more debris

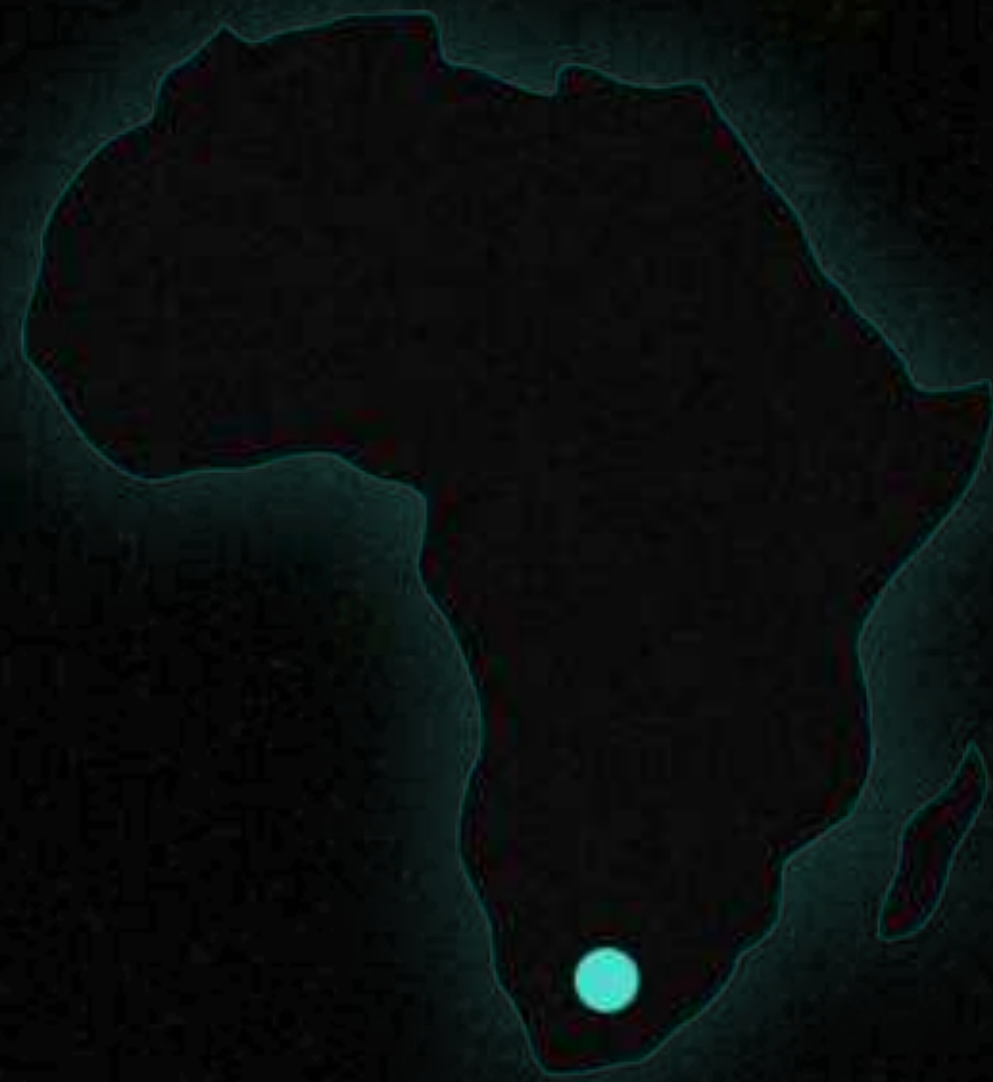
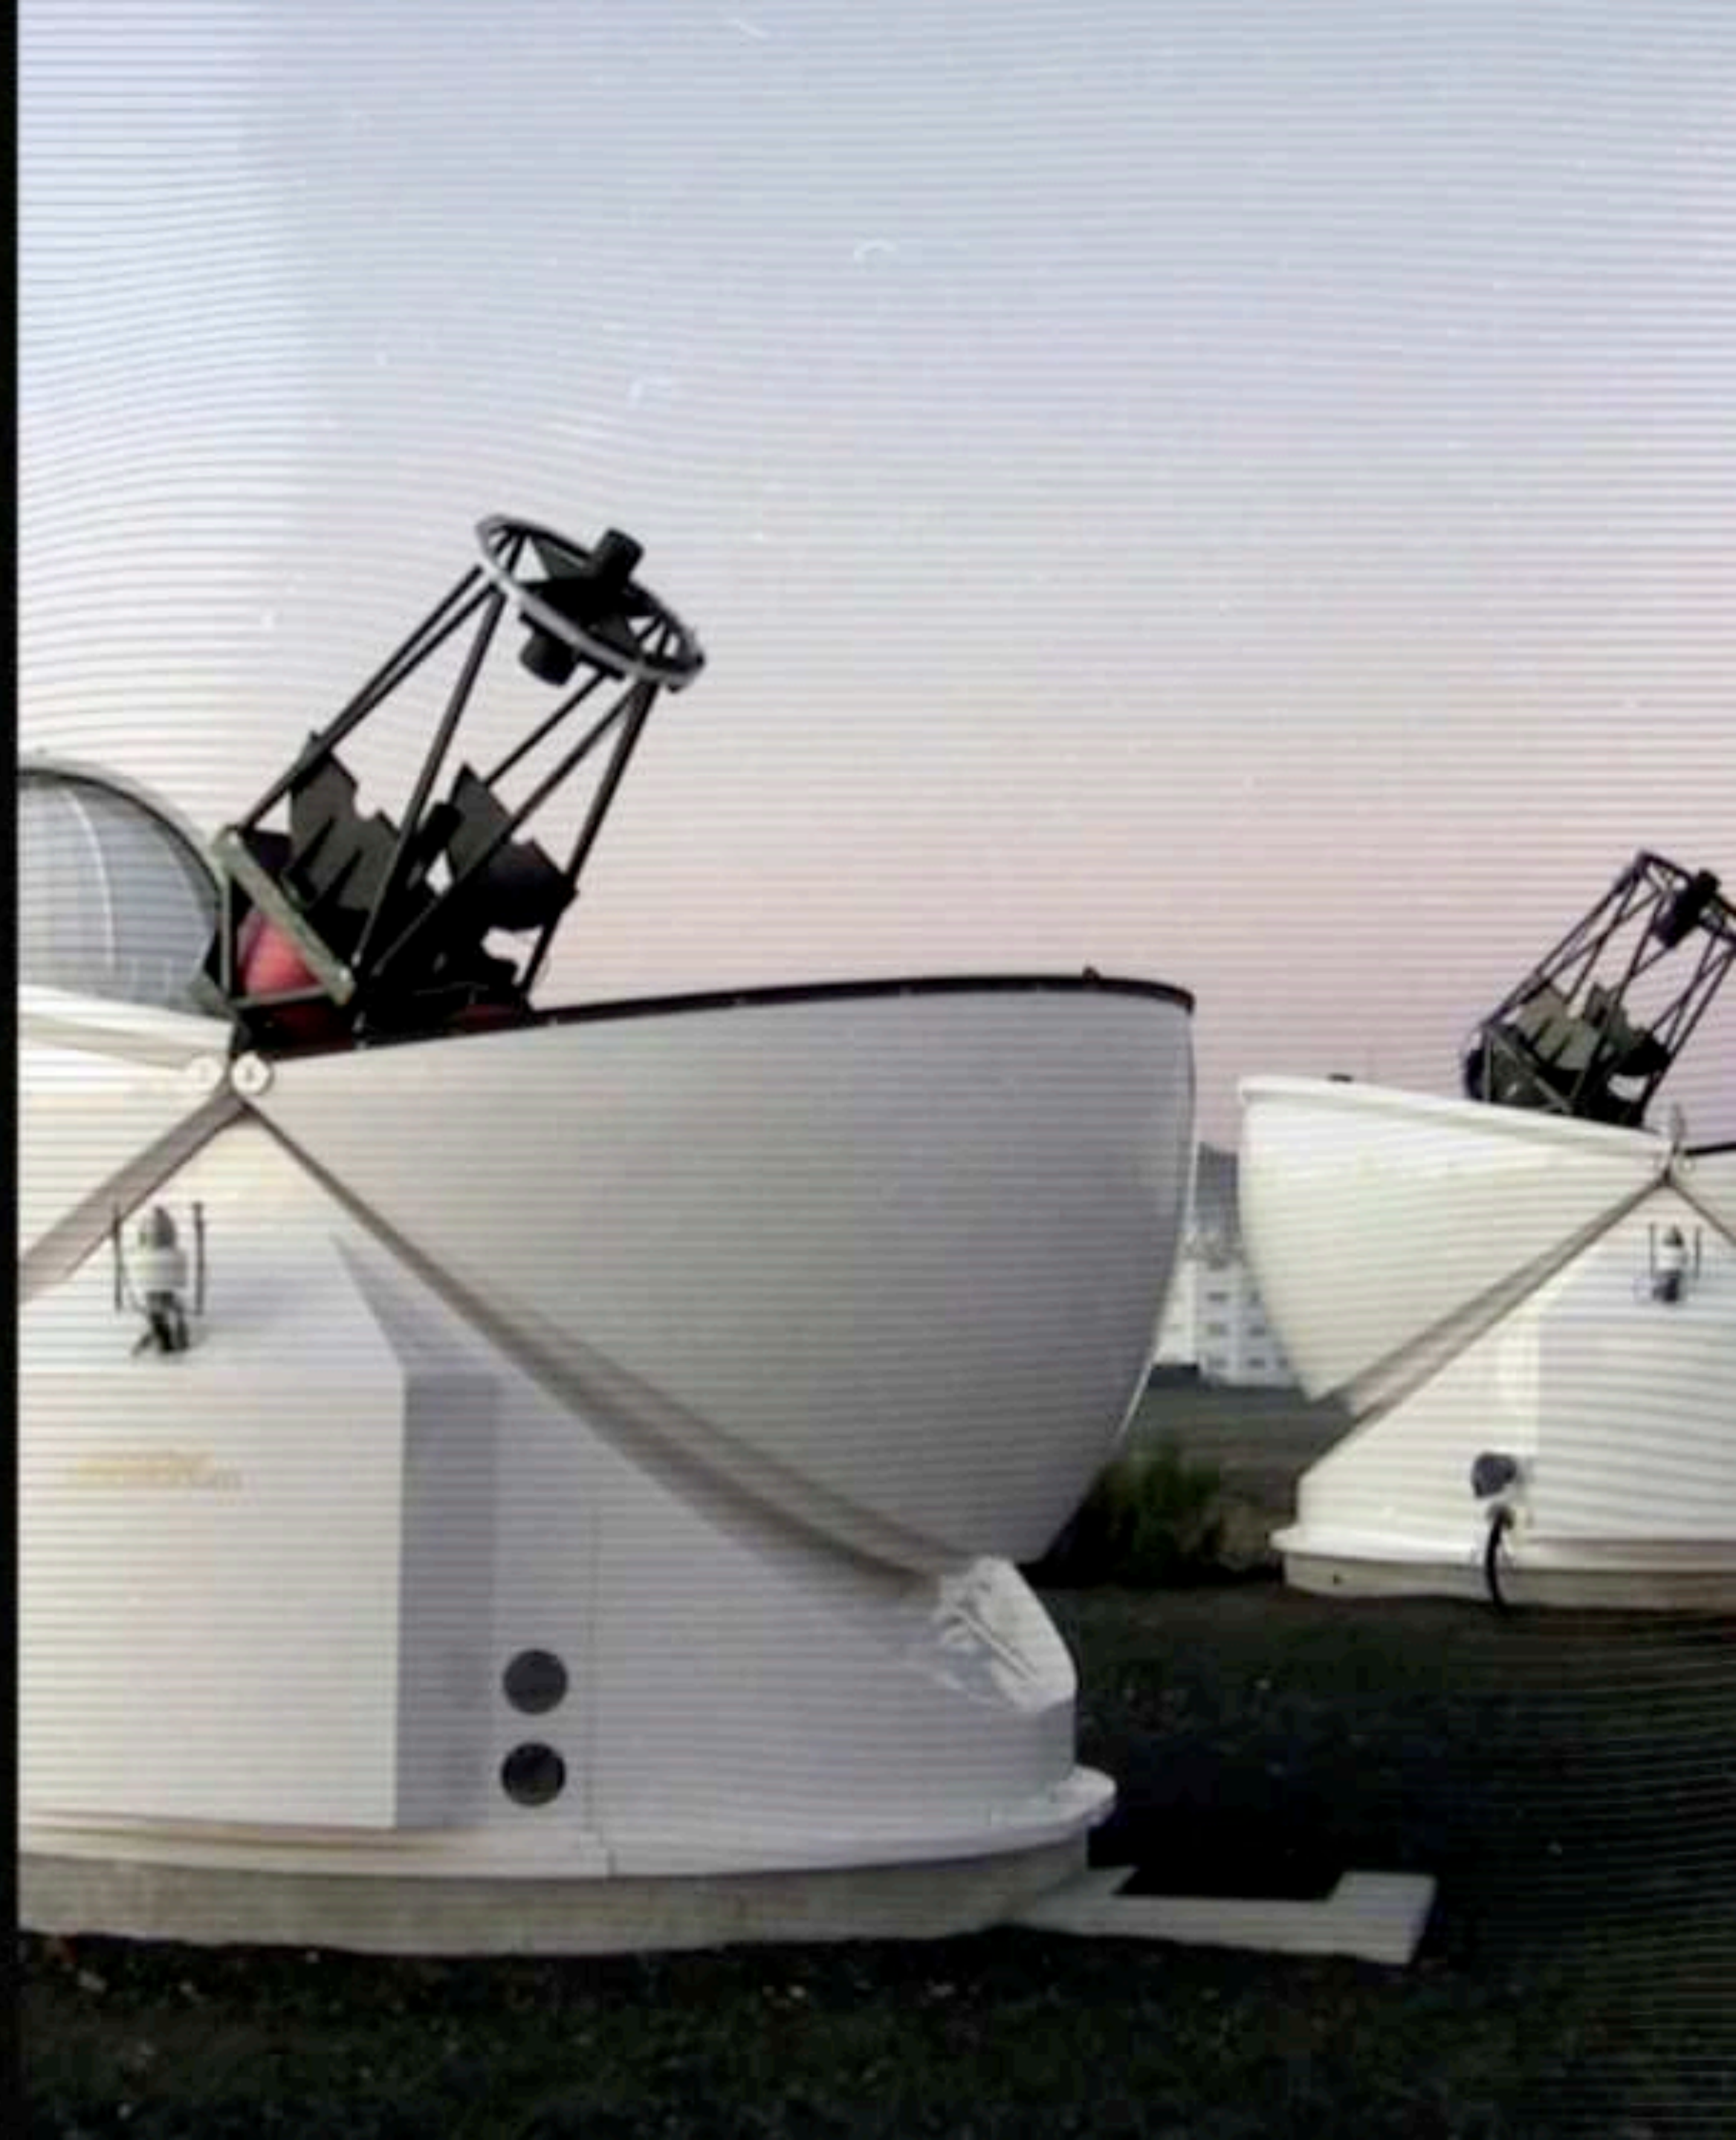
Solaris-1 and 2, NCAC PAS, SA

● South African  
Astronomical  
Observatory

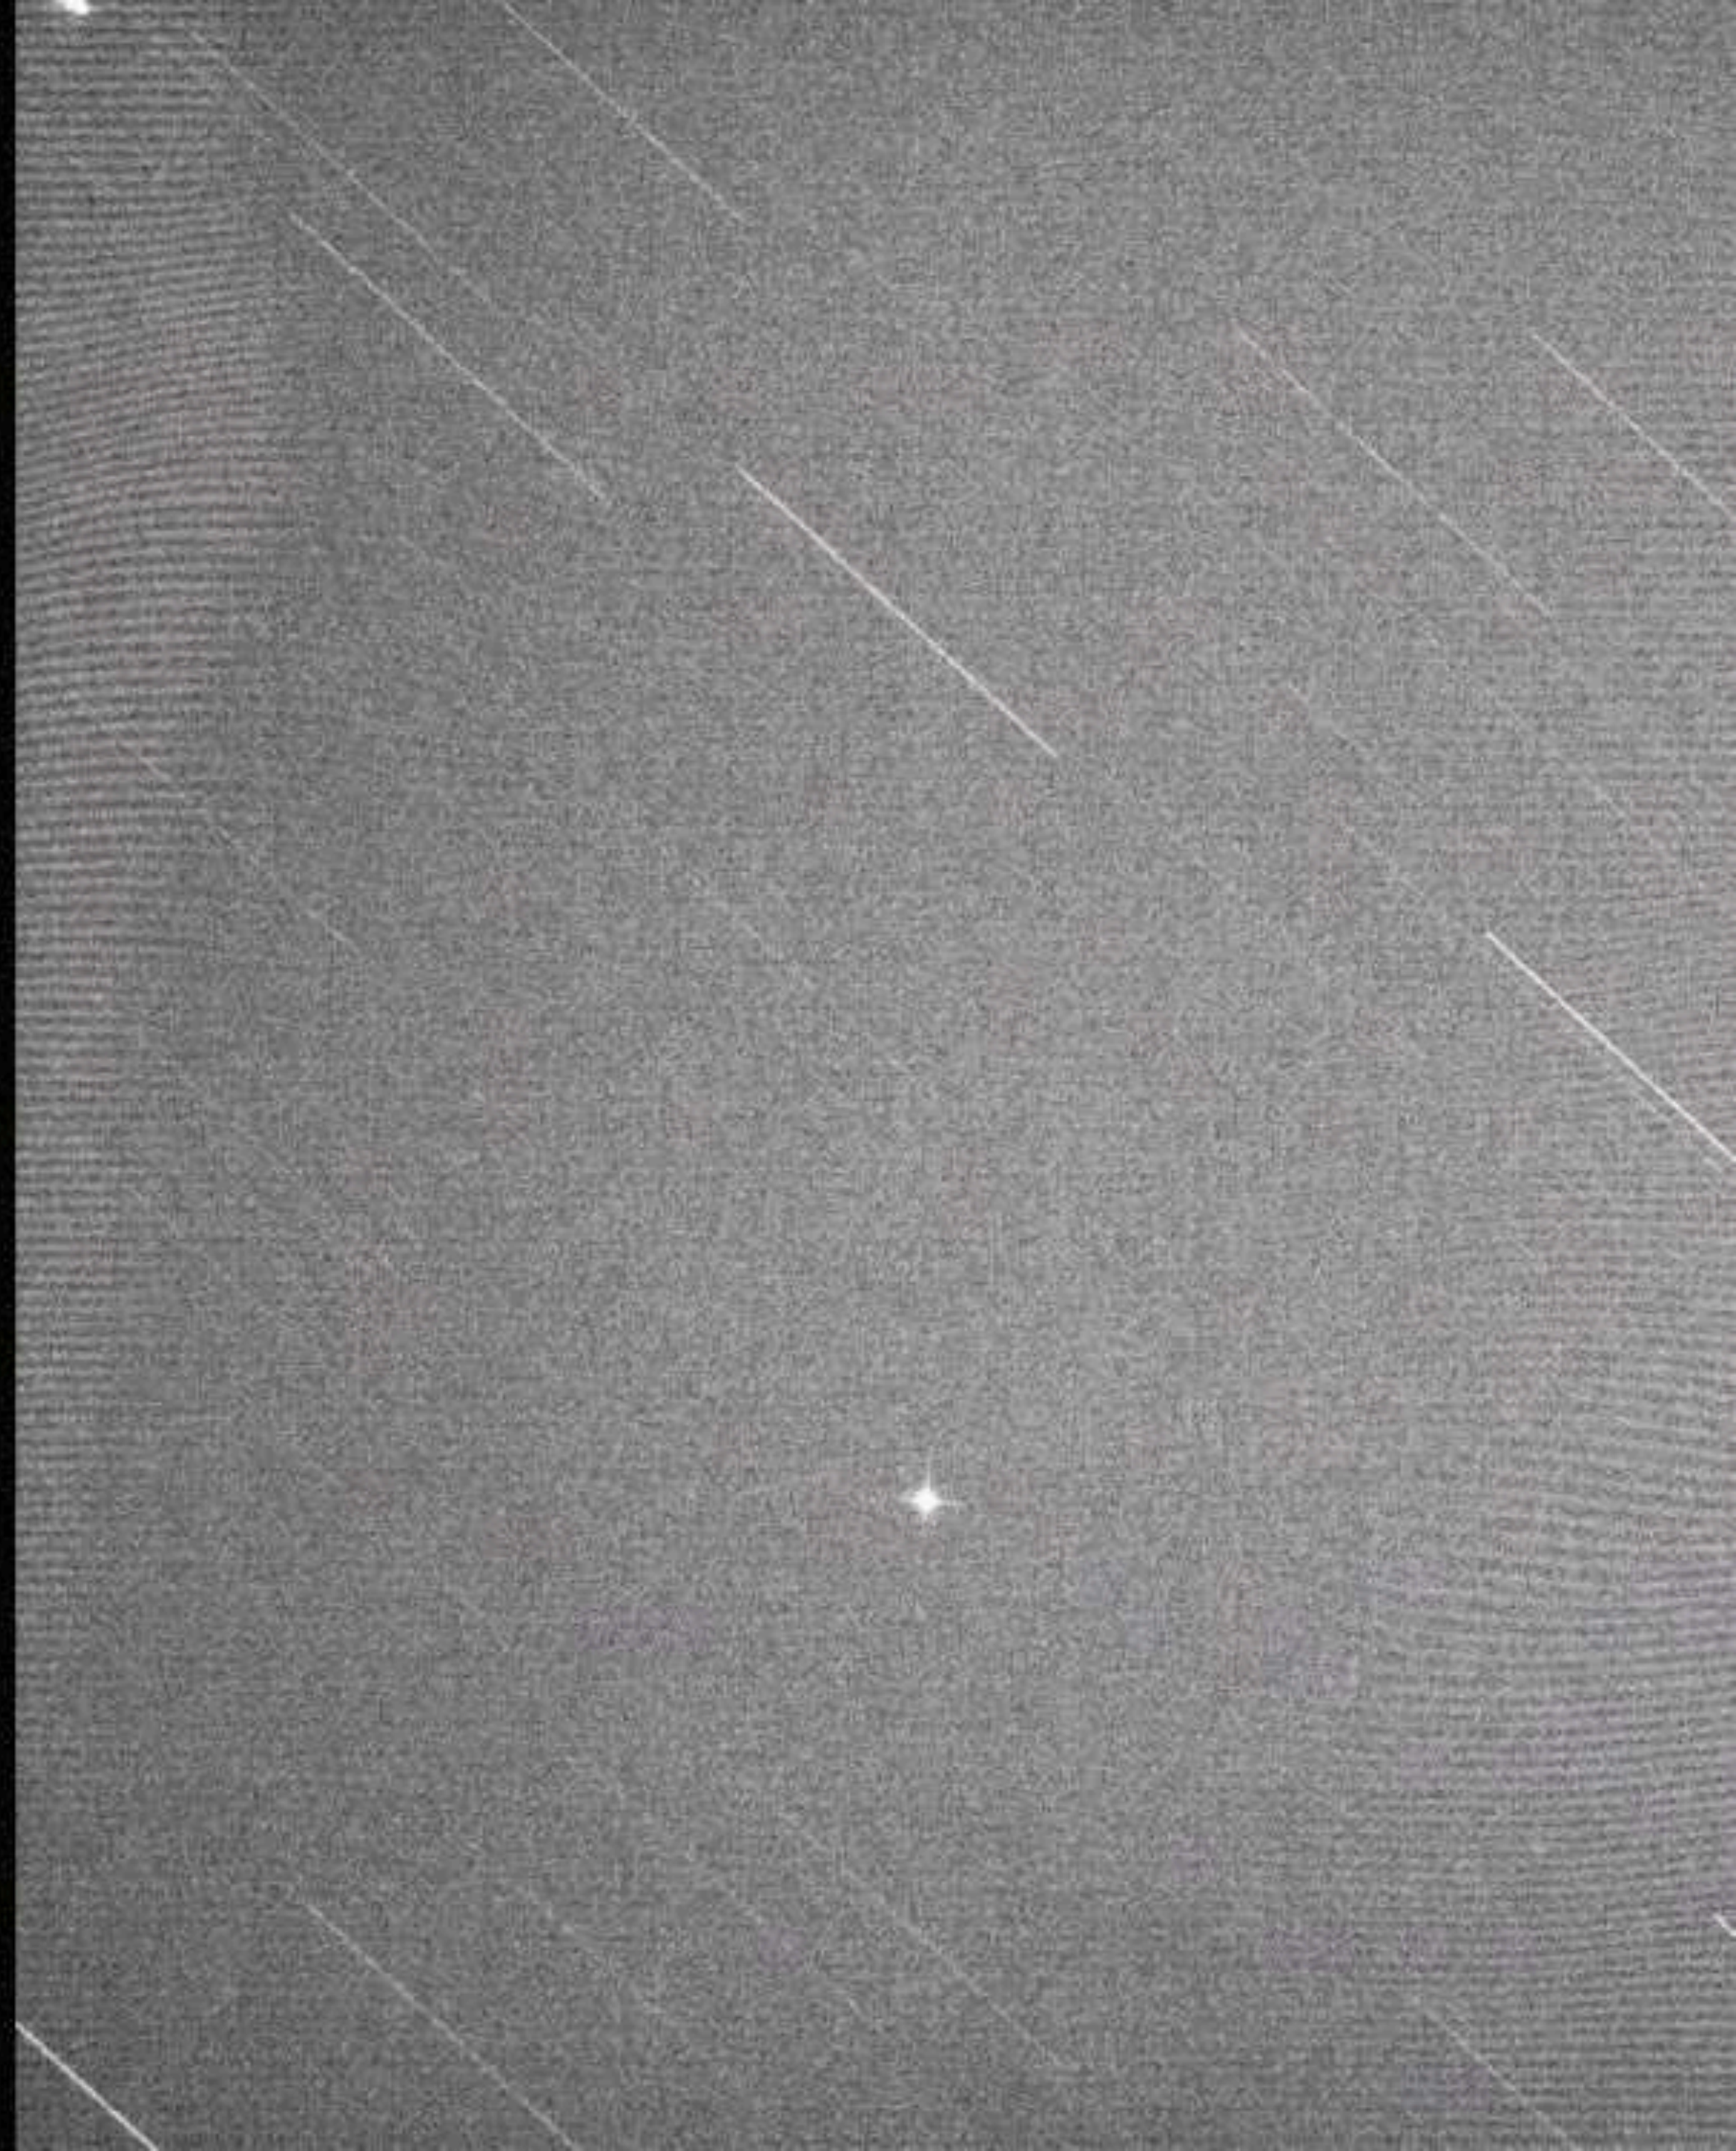
Solaris-3B, NCAC PAS, Eastern Australia

- LEO satellite
- 600 km above the Earth, orbital period 100 minutes
- 200 images, 1 minute 40 seconds
- Field of view 1.7 x 1.4 degrees
