# Space Safety

Prof. Maciej Konacki

# Space debris

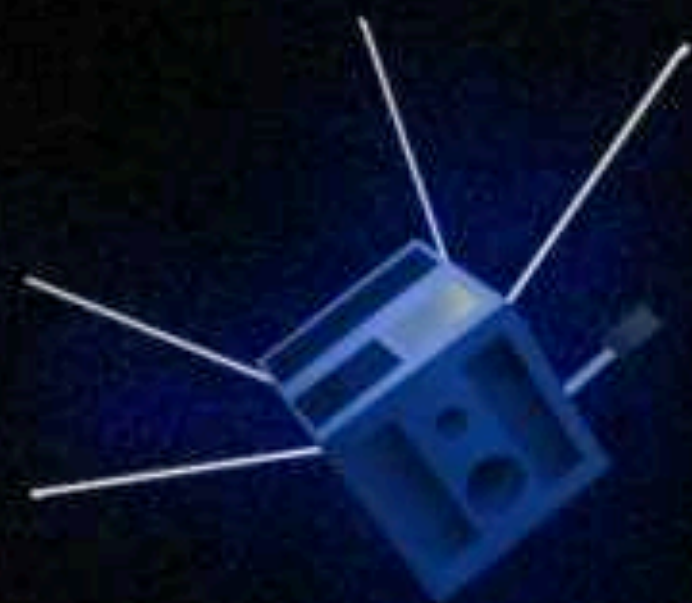
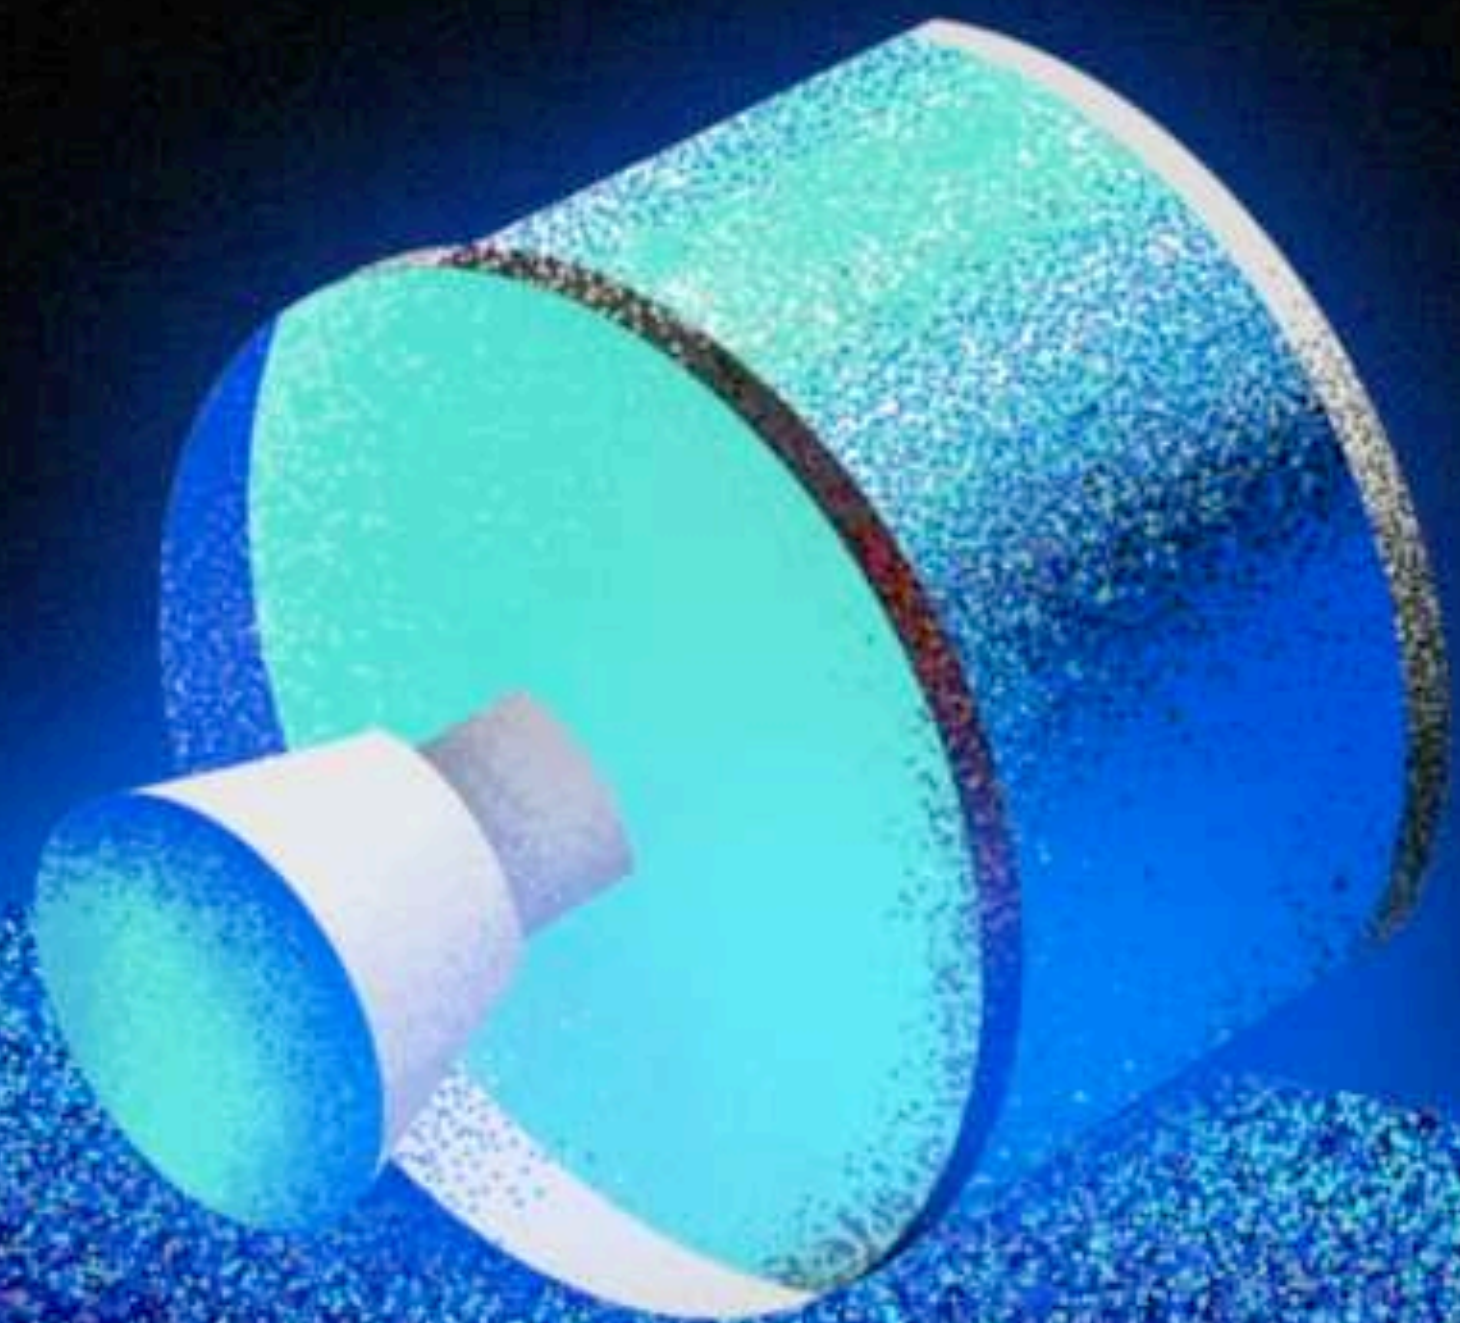
In December 2019 an old rocket stage missed a Polish scientific satellite BRITE2-PL by 5 meters
